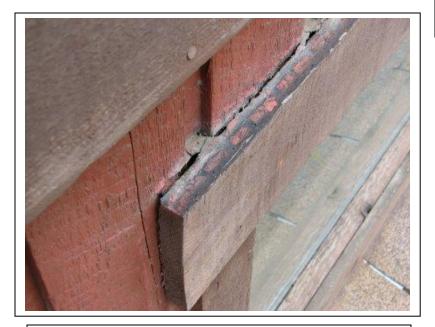
Exterior window trim (like the photo above) needs to be carefully monitored for problems like missing calk, faded paint and warped boards. Moisture gets behind this causing moisture damage around windows.

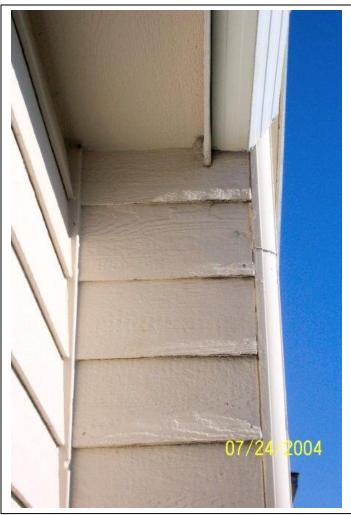
Composite hardboard siding and trim is very susceptible to moisture damage. Do you like to paint? Leaking gutters do not help.
