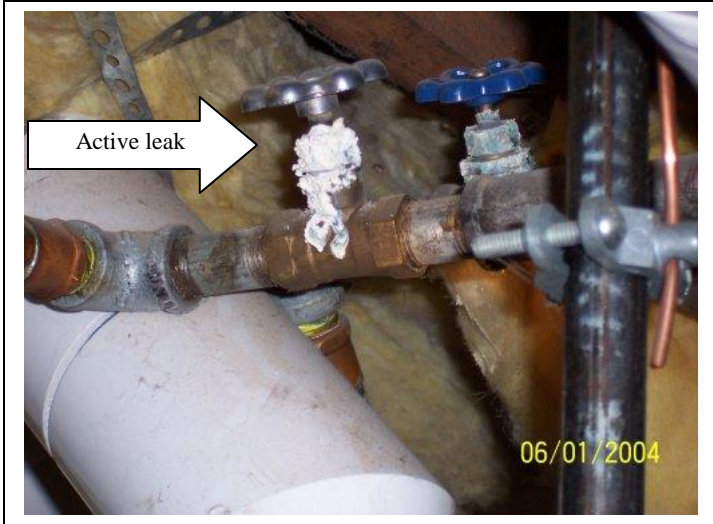
The photo above shows plumbing supply lines in the attic space. No heat, no insulation. Yes they froze and broke the following winter. Read your report carefully.
