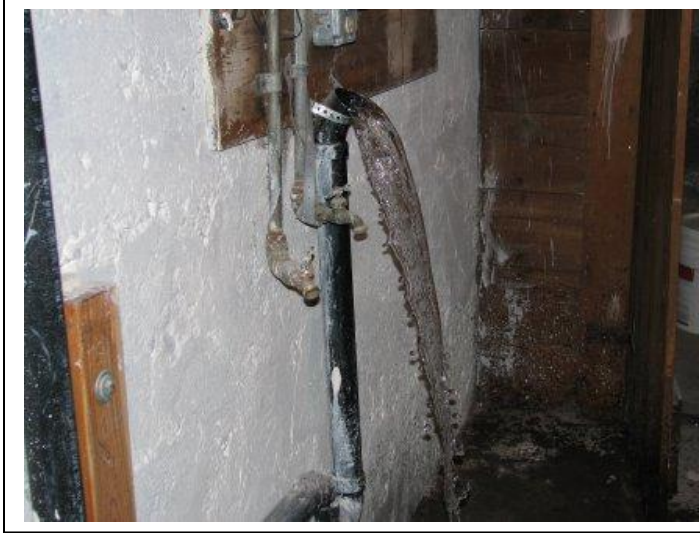
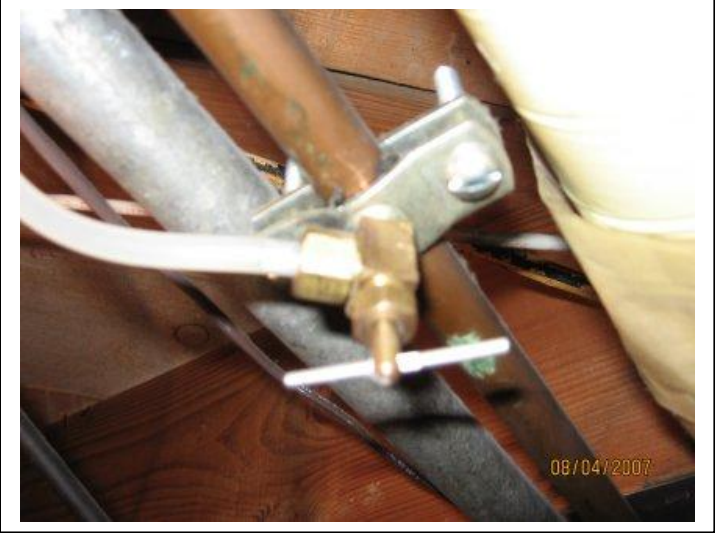
As the bathtub drained on the second floor, water started to exit out the cloths washer drain in the basement. The sewer line had some issues.
